CONTRACTOR REPORT ARLCD-CR-81059

BLAST CAPACITY EVALUATION OF A STRENGTHENED STEEL BUILDING

JANUARY 1982

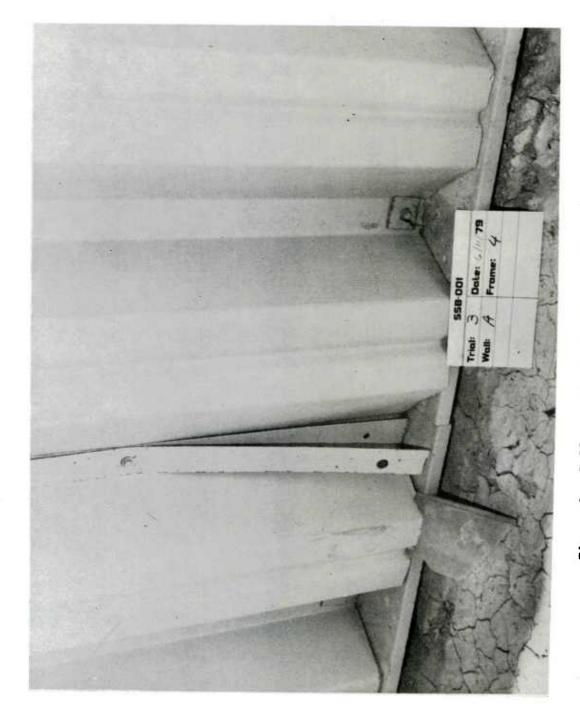
Explosives were placed 62.8 m (206 ft) from the building face (Wall A). Structural damage was apparent after test. The overlapping panel joints were opened approximately 9.5-mm (3/8-in) half way between Frames 2 and 3. In some places, the panel was slightly disengaged where it was fastened to the foundation and girts (see fig. 9). panel-to-girt screw and a panel joint screw came out between Frames 2 and 3 at the center girt. Gage D13 recorded a displacement of 45 mm (1.78 in) which corresponded to a rotation of approximately $4^{\rm O}$, greater than the reusable criteria of $0.9^{\rm O}$ for a cold-formed member. The effect of this damage was to relieve the loading on the panel, thereby reducing its deflection. Another structural damage observed was a slight web crippling at the center girt near one of the columns of the center frame.

Figure 9. Pull-out of panel seam by foundation

- 1. Providing bigger washers or other means to prevent the heads of panel screws from pulling through the metal.
- 2. Strengthening the connection of wall panels at the foundation.
- 3. Using high-strength bolts and increasing the capacity of anchor bolts to be consistent with the blast capacities of the structure.

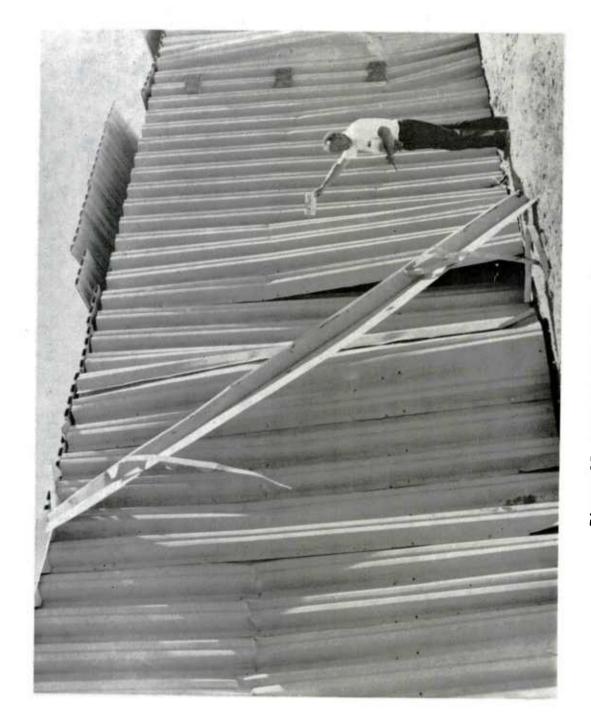
Almost all of the panels in Wall B between Frames 2 and 5 were ripped loose from the lower girt and foundation, and some of the panel seams opened (fig. 15). Web crippling was apparent in all of the girts. Slight damage was observed in the panels between Frames 1 and 2 in Wall B.

Figure 15. Damaged blastward wall
